# Investigation and Remediation of Pile Foundation, Ford Island Bridge, Hawaii

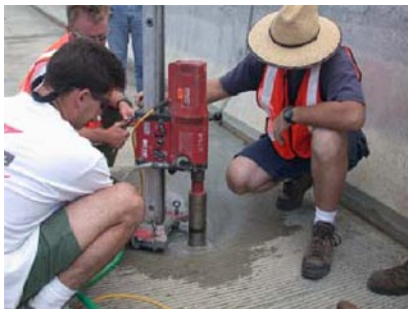
Deck inspection and core sampling.

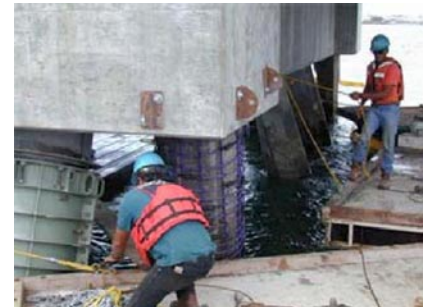
Epoxy coated steel reinforcement.
